TECHNICAL BULLETIN

MODEL/DERIVATIVE:
MGF

Bulletin N°: 0008
CDS. ref: M8377bu
Issue: 1
Date: 6.05.98

PROBLEM:
STOP LAMPS REMAIN ON - PEDAL SWITCH OVER ADJUSTING

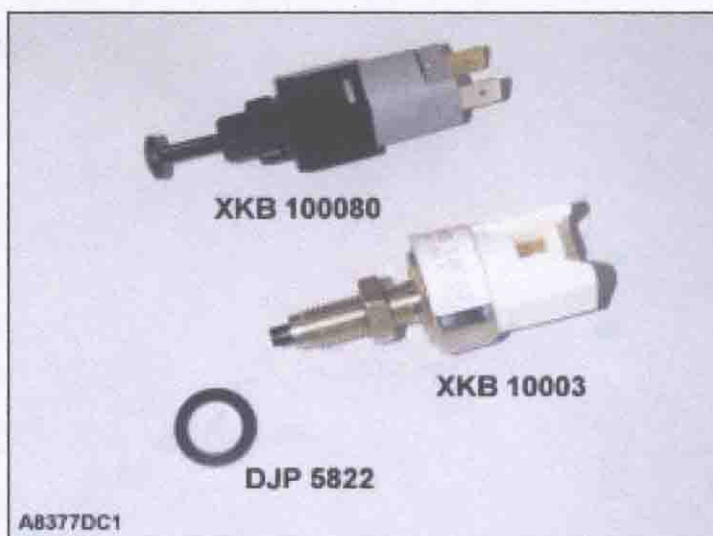
CAUSE:
Unnatural upward movement of brake pedal causes brake switch self adjuster to over adjust. This condition can occur if driver unintentionally lifts pedal with foot.

ACTION:
Replace the original brake light switch XKB 100080 for alternative switch part number XKB 10003. This switch is non self adjusting and will require a different fitting procedure to that provided in the workshop manual.

Switch replacement and setting:

1. Release original switch XKB 10008 from bracket, disconnect electrical connections then remove and discard switch.
2. Remove one of the black plastic sleeves from the electrical connector.
3. Reconnect the electrical connections to new switch XKB 10003.
4. Assemble the 7 washers to new switch.
5. Hold switch in fitted position but do not fit brass nut.
6. Switch ignition on and ask assistant to check for brake light operation.
